Luigi Di Cosmo

EFFECTS OF THE LATEST EARTHQUAKE

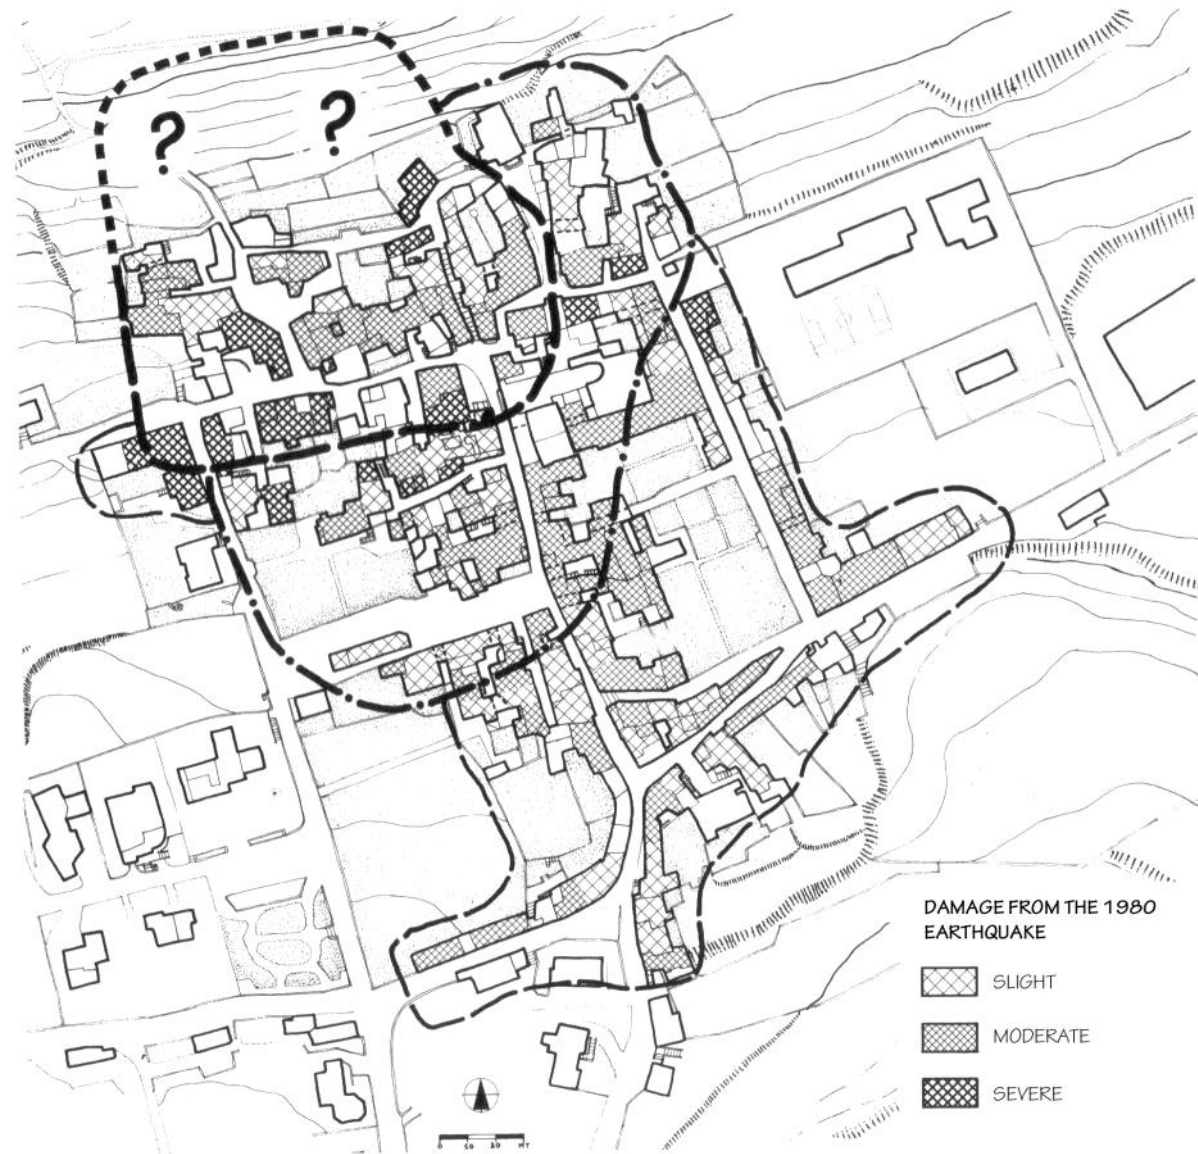
1) Damage

The damage caused by the earthquake to private dwellings shown in the tables is that recorded on standard forms which were used throughout the area affected by the earthquake of 23 November 1980 and drawn up by the technical officers appointed by the authorities of the commune.

The indicators used to classify the damage were as follows:

SLIGHT: isolated cracks, widespread cracking, cracks in roof ridges (all minor); discontinuities in roofs, sagging of wooden floors.

MODERATE: widespread cracks, cracks in roof ridges, cracks at wall crossings (all minor); discontinuities in roofs, sagging of wooden floors, longitudinal cracks in any hollow block iron floors or iron floors with vaulting cells made of tuff or brick. Some rooms of the house have to be evacuated.

SERIOUS: widespread cracks, cracks in angled joints, cracks at wall crossings, compression cracks (all wider than average); discontinuities in roofs, sagging of wooden floors, longitudinal cracks in hollow block iron floors, or iron floors with small arches made of tuff or brick, cracks in any ceiling vaults. Building has to be evacuated.

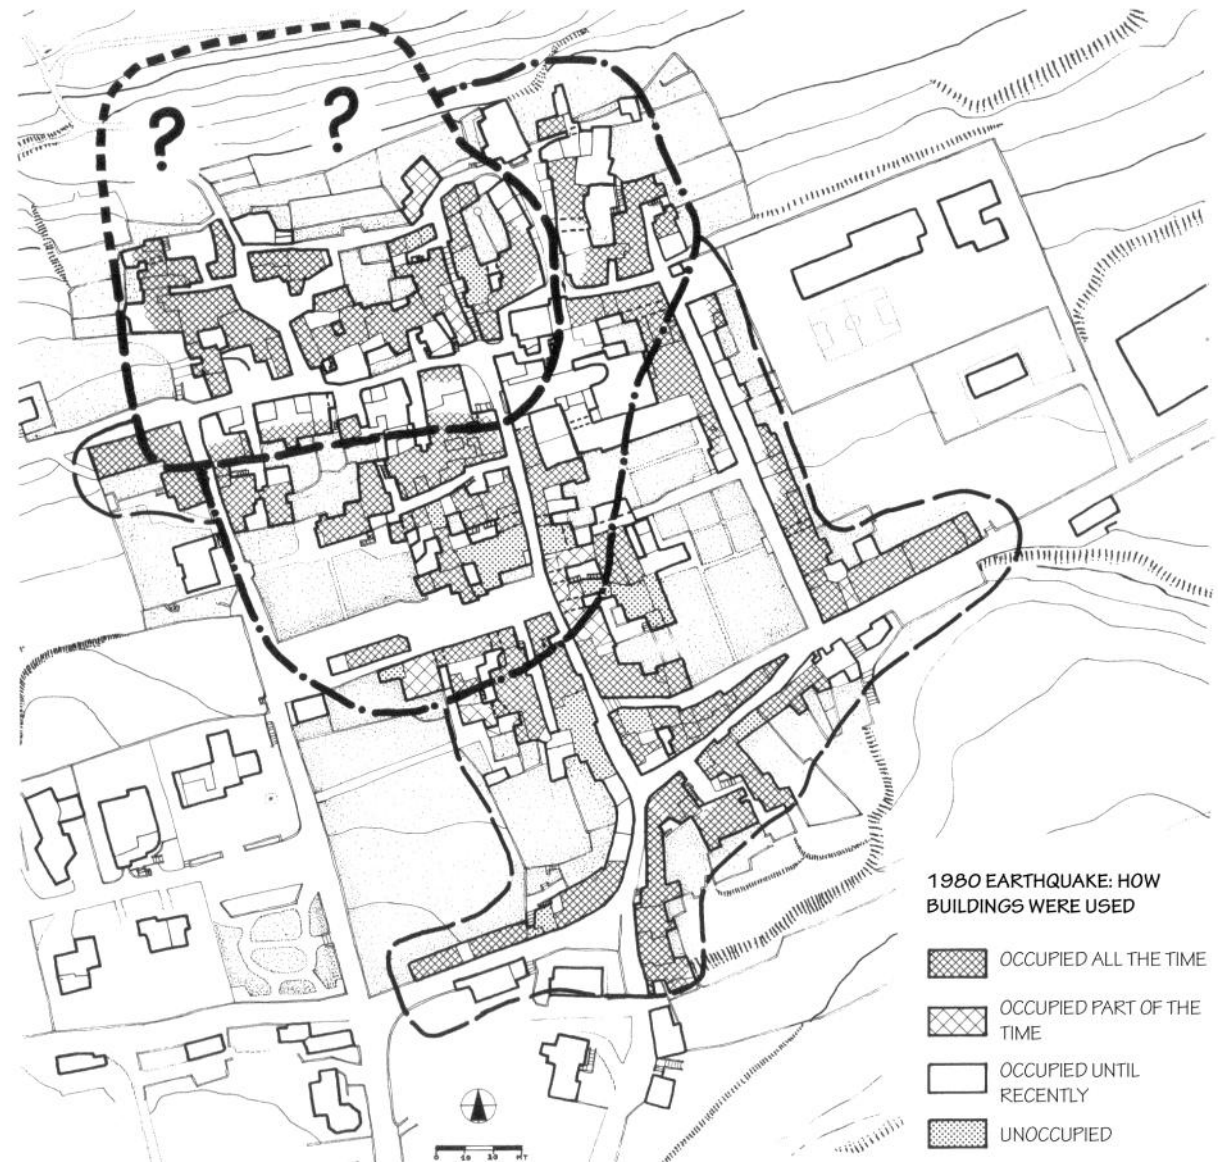
2) Occupancy

This parameter describes how the various dwellings were used in the last 10 years preceding the earthquake, classifying them as follows:

- occupied all the time;
- occupied part of the time;
- occupied until recently;
- unoccupied.

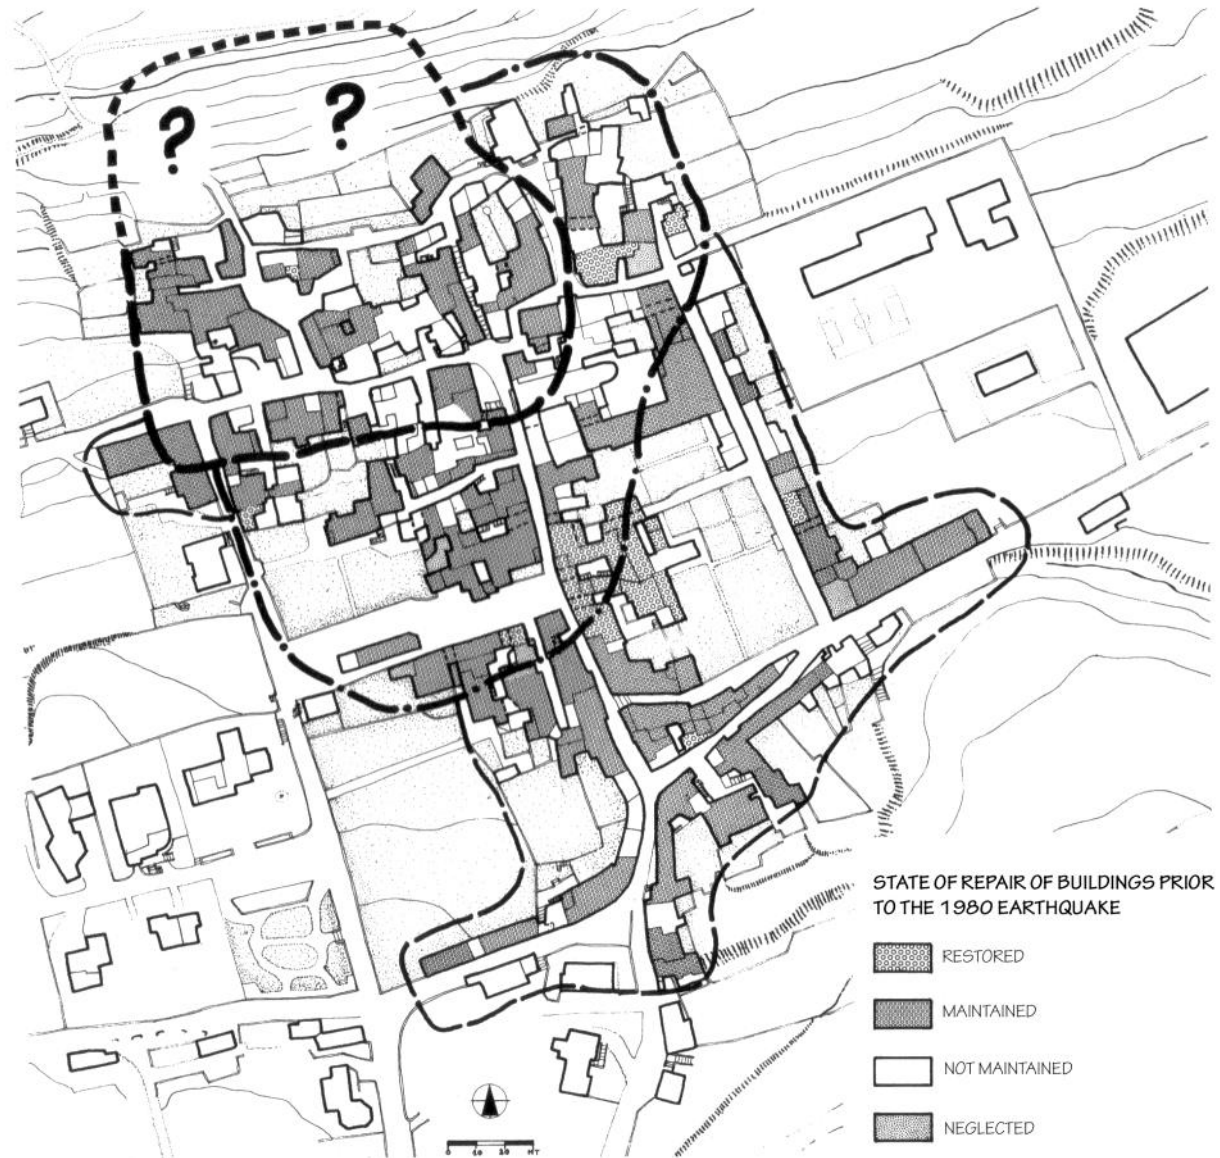
a) maintenance

Maintenance was valued on the basis of measures taken during the 10 years prior to the earthquake. Buildings were classified as follows:

MAINTAINED: buildings which had had floors or certain wooden lintels replaced, the roof repaired and the plumbing improved;

RESTORED: buildings which had not only had specific restoration work done on them but had also been the subject of more major work such as: replacement of wooden floors, repairs to the roof, measures involving load-bearing walls (demolition and reconstruction or reinforcement); measures involving the foundations;

NO MEASURES TAKEN: none of the types of work mentioned above had been done;

NEGLECTED: not only had no work been done on the building, it had been poorly used and gradually fallen into disrepair as a result.

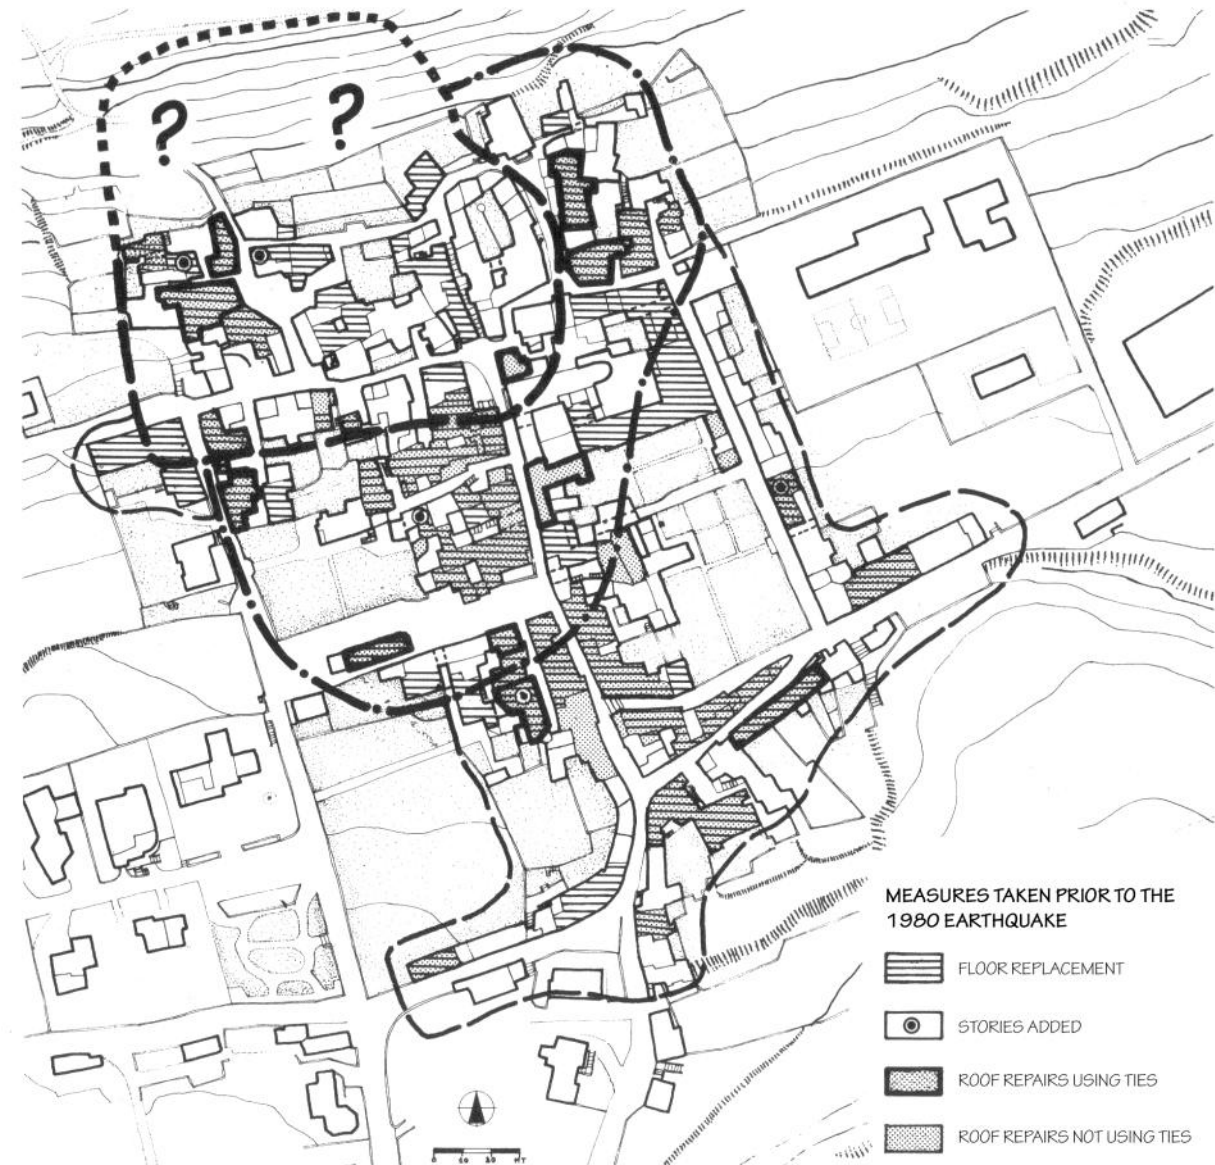
b) maintenance and static reinforcement

This diagram shows in detail the improvements to each building (made in every case prior to the earthquake of 23 November 1980). This analysis is of course already included in the previous table a).
