## Problems of Airborne Particles : Their Effect on the Famous Frescoes of Masaccio Masolino and Filippino Lippi in Florence

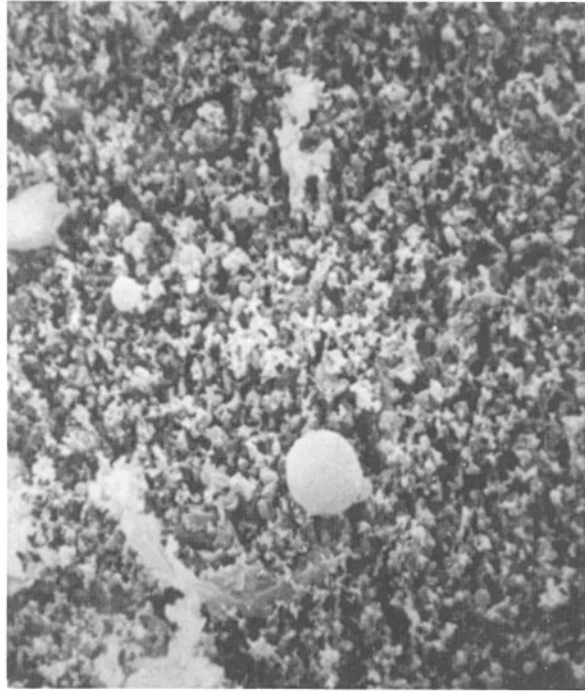
*Fig. 2. Electron micrograph (SEM) of dust at a magnification of X 1000.*

The nature of the dust collected by the pumps through a cellulose membrane is shown in Fig. 2 and 3. The scanning electron microscope, SEM, reveals the dust in the particles. We obviously made measurements on this dust with X-ray diffraction, Auger and XPS spectroscopy, mass spectroscopy when possible, and with X-ray fluorescence, in order to determinate the principal elements.

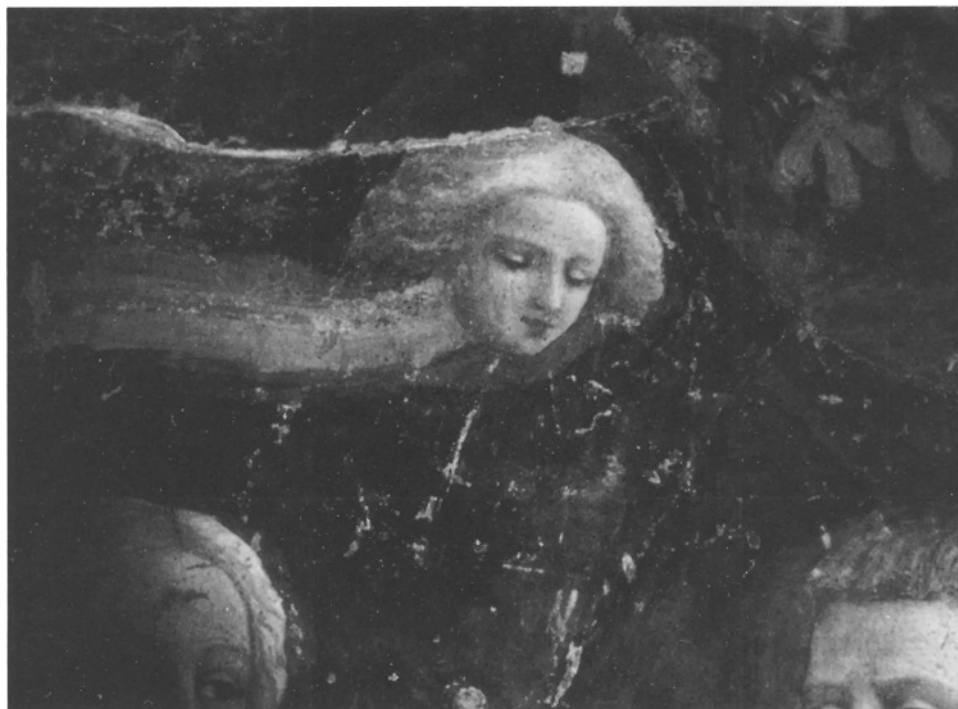
Fig. 4. Masaccio's fresco in the Cappella Brancacci after cleaning - Detail.

This cycle of frescoes, virtually a landmark, the culmination of XVth century Italian painting, was recently restored to its pristine splendor by one of the most effective scientific interventions ever performed in Italy, whose details obviously cannot be described now (see Fig. 4).
