Ferruccio Ferrigni, Assunta Lavorgna

STRENGTHS AND WEAKNESSES

Vulnerability factors

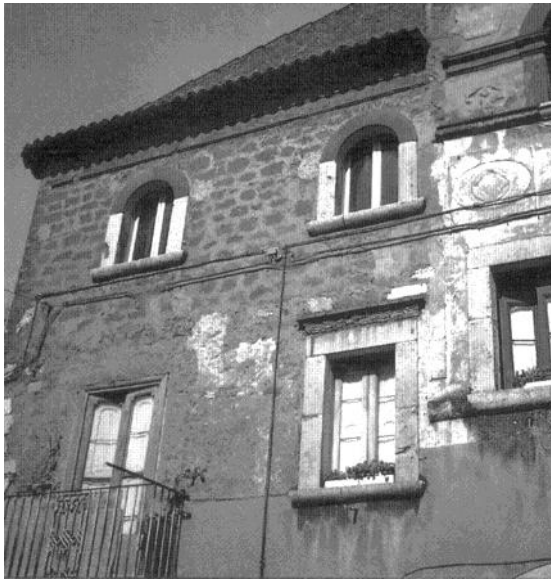
The map of vulnerability factors is a useful aid in identifying the constituents of a community's

earthquake culture. It includes not only older factors which used to be well known (excessively large openings or corner openings, chimneys and vents, etc.) but also modern features of buildings and architecture which have become vulnerability factors due to lack of maintenance or because buildings are put to a range of different uses, etc.

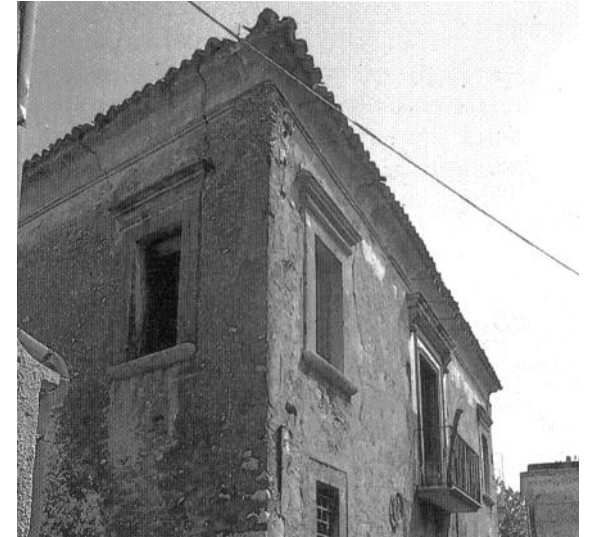
The list of old and new vulnerability factors includes:

- **bays** which are **excessively wide** relative to the wall;
- the **position of openings** relative to the intersections of walls (often, both inside and outside, older and more recent gaps are found close to the crossings of walls and roof ridges);
- **older and more recent floor additions**;
- recessed **chimneys and vents**;
- recessed **rainwater downpipes made of brick**, with a very wide diameter (up to 20 cm);
- infiltrations due to the type of **dripstone** used for windows and balconies;
- **partial reinforcement work** (e.g. reinforced concrete applied on top of rough-walling).

It was found that certain features, such as rainwater downpipes which are recessed (and which no one knows how to repair these days), or roof spaces converted into attics, were things which caused buildings to become run-down faster and thus made them more vulnerable.

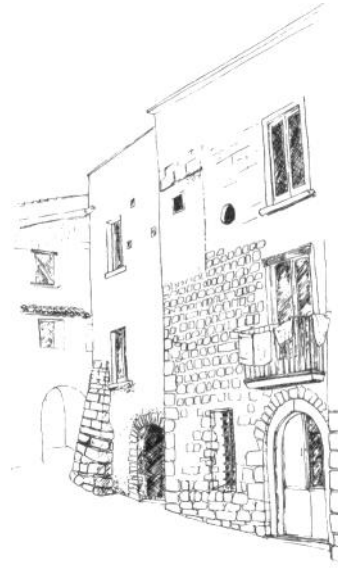
Anomalies which eliminated earlier vulnerability factors and can thus be regarded as reinforcement techniques forming part of San Lorenzello's earthquake culture are as follows:

- **buttresses**, traditionally of stone, and more recently of brick, used to shore up points of local deformation, are a method of reinforcement and repair;
- **wall bracing**, angled or vertical, is a general preventive measure, however. Our analysis of the methods used suggests that all such bracing was constructed after the 1688 earthquake. Comparison with Cerreto, where none of the buildings in the oldest part have wall bracing, proves that this technique was always used for subsequent reinforcement and not as part of the original construction work;
- **tie-beams**, terminating in tie bolts and plates, were little used, and only from the 19th century onwards, when new regulations made streets and

passages no longer communal areas but publicly administered areas, so that it was no longer possible to strengthen roof ridges by building vaulted passageways or staircases supported by rampant arches;

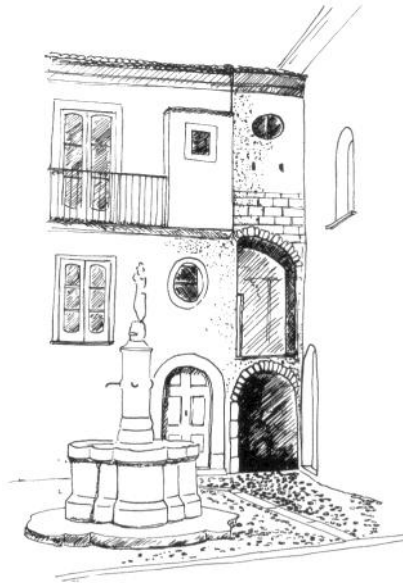
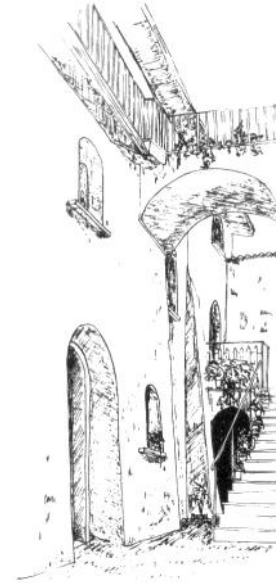
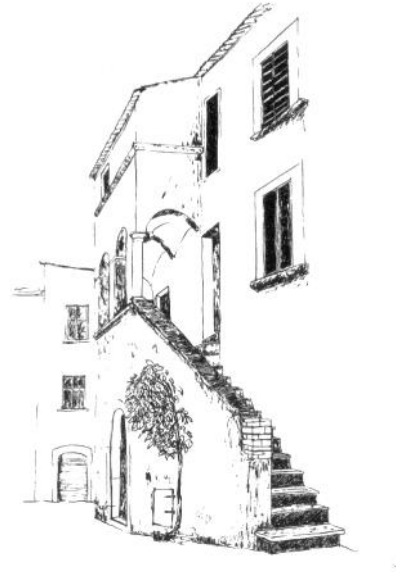
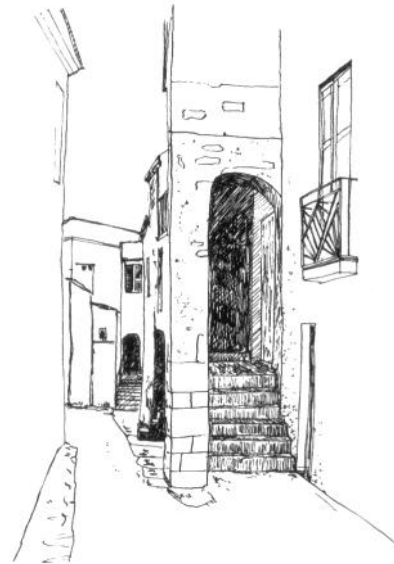
- **vaulted passageways** of tuff or rubble. Originally additions which combined static reinforcement with improvements in amenities, these became a regular feature of the architectural repertoire and are now incorporated into new structures right from the start.
- "**contrast**" arches made of tuff, at the topmost point of buildings, probably serve as a barrier to cracks caused by the thrust of the roof or rotation of the walls. They are used when the part of the wall concerned is too high so that a new room or

staircase cannot be built whilst reinforcement work is being carried out;

- **staircases, supported by rampant arches** between two buildings are the simplest use of a "contrast" feature;
- **outside staircases**, sometimes with a terrace or loggia, may have become necessary when properties were divided and separate access was required. But the fact that they were accepted by the community even though they take up a considerable area of common ground suggests that they were essential to balance the building;
- **extensions**, usually to the ground floor, so that its roof can be used as a terrace.
