Ferruccio Ferrigni, Assunta Lavorgna

### ... BUT NOT SO STRANGE REALLY

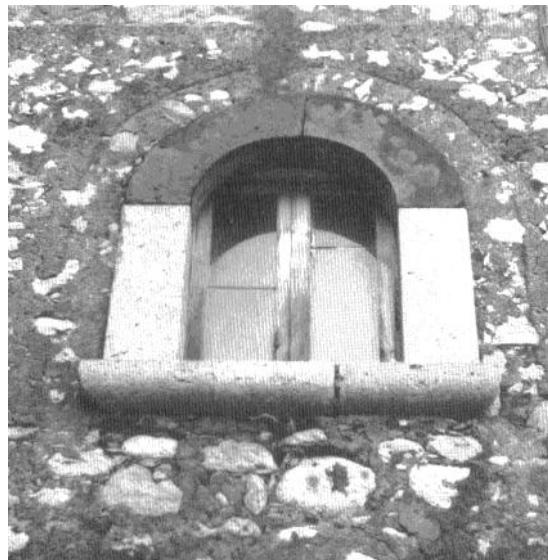
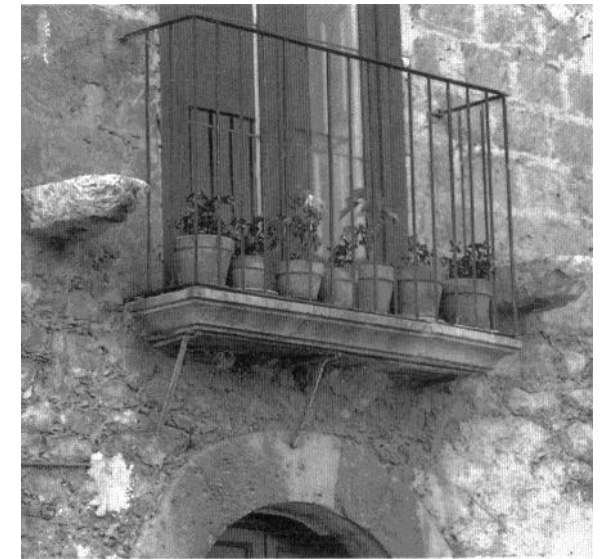
- some window-sills in the old part, which probably experienced the earthquake of 1688, are made in a single piece and are cracked;
- all window- and balcony-sills in the part built after the 1688 earthquake are constructed in two parts;
- balcony-sills constructed just before or some time after the 1805 earthquake project much further, are made in a single piece and are nearly all fractured.

Reasoning in terms of earthquake culture it was suggested that the frequency of window-sill cracks caused by the 1688 earthquake showed the inhabitants that this was a natural way for structures to behave. But when the sills are broken and displaced, the rough surfaces of the crack prevent the divided parts from moving freely against each other; they get stuck. The fractured sill thus loses its original set, and the frame has to be repaired or replaced. It would thus appear logical for people to have constructed their new sills "ready-split". The smooth, non-contiguous surfaces of the two divided parts allow them to slide past each

other when the earthquake strikes and then return to their original position. This technique was probably successfully tested in the course of the century and in the 1805 earthquake, and until fairly recently the two-piece sill was a typical feature of the well defined and readily identifiable "San Lorenzello window".

The question of balconies is different. Functional necessity, together with the desire to emulate the balconies of the more affluent houses, caused sills to be built projecting further and further outwards. But whilst a sill projecting by only 20 cm will hold without being end-fixed (it extends 40-50 cm into the interior and is thus held up by the wall), sills which project 50-60 cm will lift if they are not end-fixed. Consequently they must extend beyond the width of the opening at both sides.

When the original intention that the structure should be earthquake-resistant inevitably became forgotten, the consequence was inevitable too: new sills

were cut from a single block of and failed withstand the next earthquake which came along (1930?).

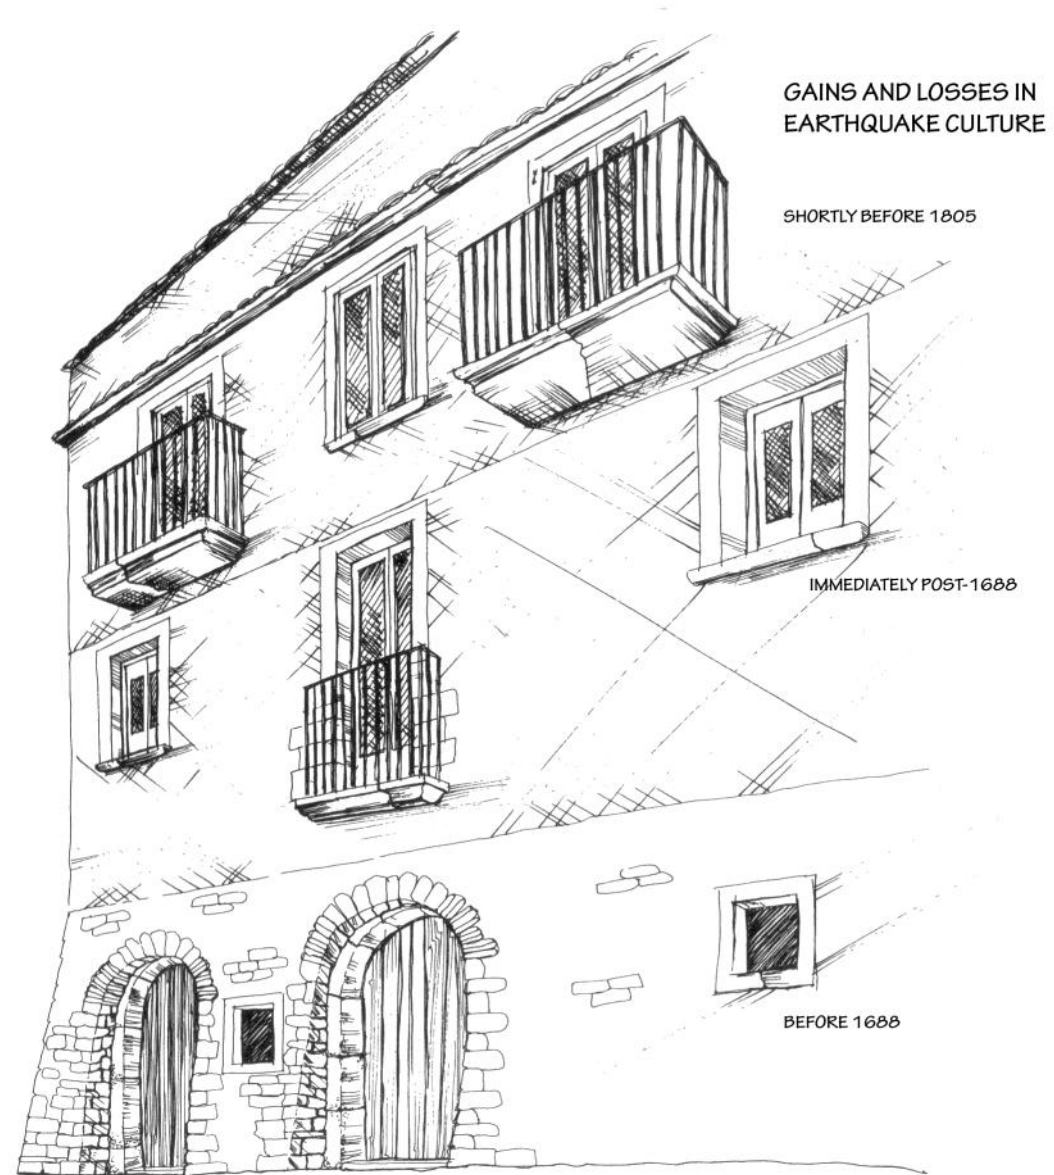
We thus extended our analysis to the neighbouring village of Cerreto Sannita. This was destroyed by the 1688 earthquake and totally rebuilt soon afterwards on a different site. Its buildings can thus be dated exactly and they are unquestionably representative of the earthquake culture of the period. In Cerreto, *all* the window-sills are in two parts, though the vertical

members are often longer than the sill itself, as in San Lorenzello.

A number of questions persist, however: why are the two parts not equal in length? Why are their relative sizes always constant and very close to the golden section? Why is the smaller block nearly always on the right?
