## The Influence of Air-Pollution on Ancient Monuments, Buildings, and Museum Objects

### *Abstract*

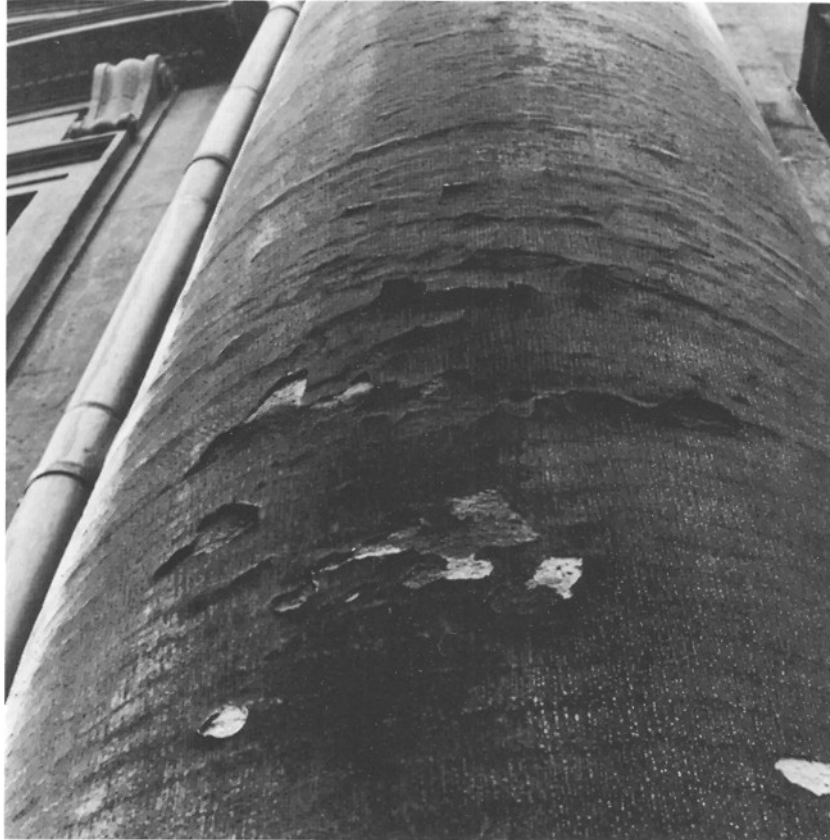
*Fig. 1. The crackling and exfoliation of the black crust on one of the columns of the Marble Church in Copenhagen.*

Repeated wet and dry cycles will cause repeated deposition of gypsum and the porous crust which is formed has little or no attachment to the stone. The result will be crackling of the stone and exfoliation. Soot-particles, which find excellent conditions for deposition on the porous surface, give a black colouring to the crust (Fenger and Brinch Madsen, 1982).

The Marble Church in Copenhagen bears strong marks of the city's polluted air. On the four columns at the entrance to the church both white and black areas are visible. The white areas occur where rain water can run freely down the stone ; the acid water dissolves the calcium carbonate, and keeps the stone « clean ». The black areas, occur where the stone is not exposed to running water (Fig. 1).

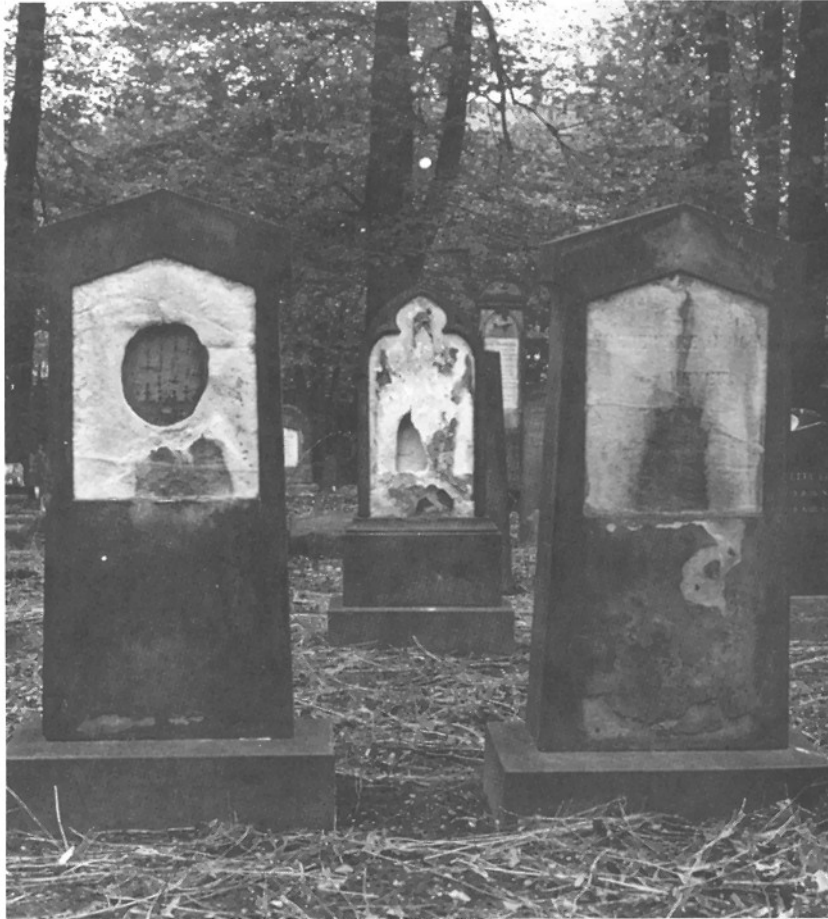
*Fig. 2. The damage caused to grave monuments at the Mosaic Cemetery in Copenhagen.*

Gravestones with inset marble slabs are damaged when the calcareous matrix, binding the calcium carbonate grains in the marble, is dissolved by acid rain. The marble becomes porous and is, therefore, able to absorb more water which, in winter, freezes and there fore expands, and moves the individual grains further and further apart. The marble slab forms a swelling which, at some point, will rupture (Fenger *et al.*, 1984) (Fig. 2).

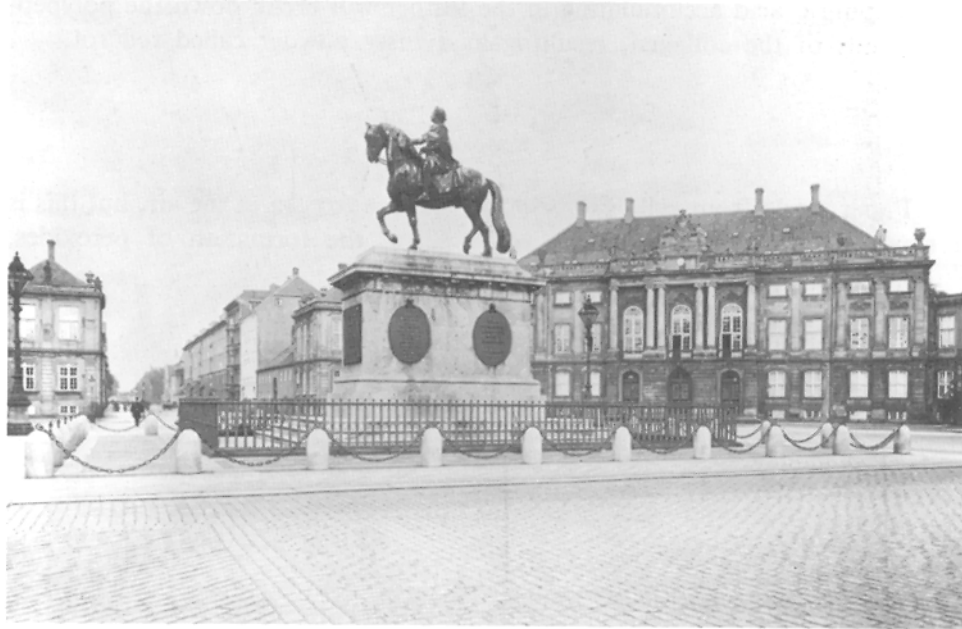
*Fig. 3. F.J. Saly's equestrian statue in bronze, from 1912.*

In the courtyard of Amalienborg Castle in Copenhagen stands F.J. Saly's equestrian statue of King Fredrik V (1723-1771), which was unveiled in 1770. Its surface varies in colour from pale, light green on all the surfaces exposed to the rain, to black on the better protected parts. The black parts exhibit a surface which is very much like the original one. In contrast, all the green parts are more or less etched in such a way that the original surface has been erased. The green corrosion layer is extremely thin and forms no protective covering for the bronze (Fenger and Brinch Madsen, 1982). Corresponding effects can be documented for many bronze sculptures in Copenhagen.

Figures 3-5 show the development of corrosion on the statue. Between 1912 and 1962 hardly any change can be seen but between 1962 and 1983, the change is enormous.

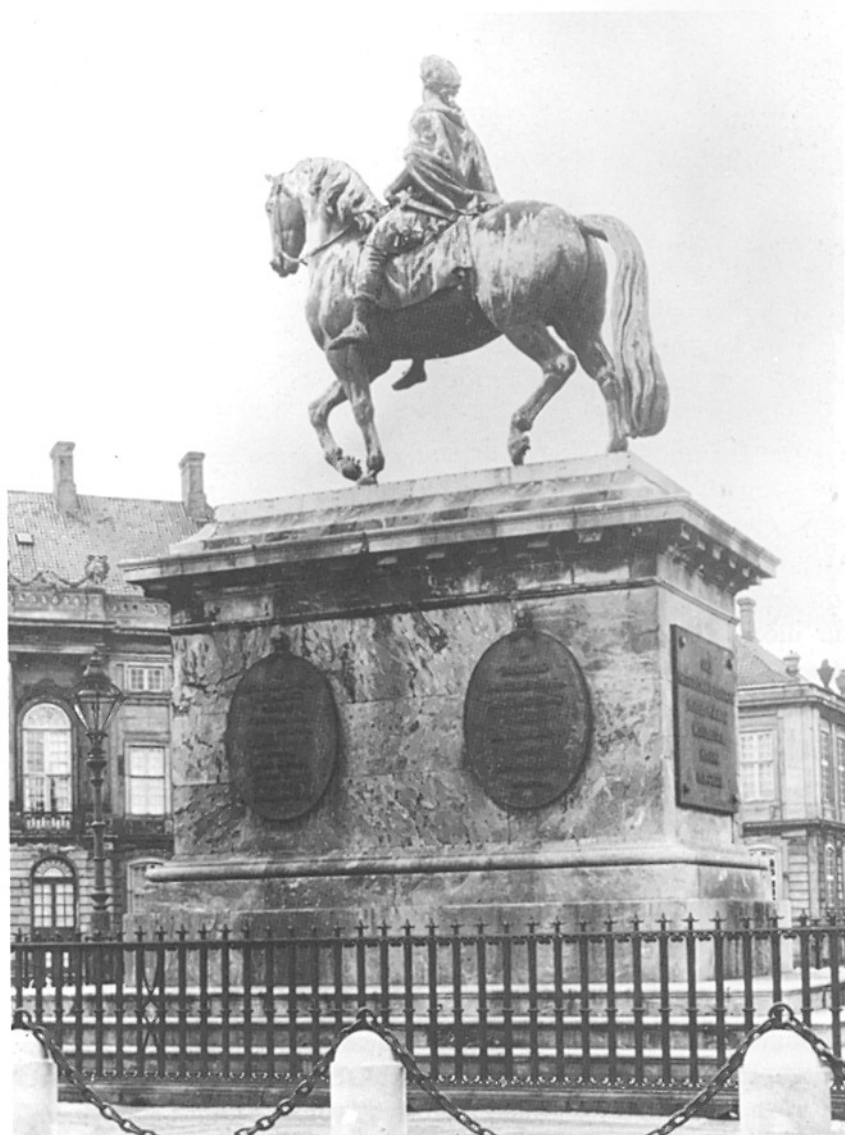
*Fig. 4. F.J. Saly's equestrian statue in bronze, from 1962.*

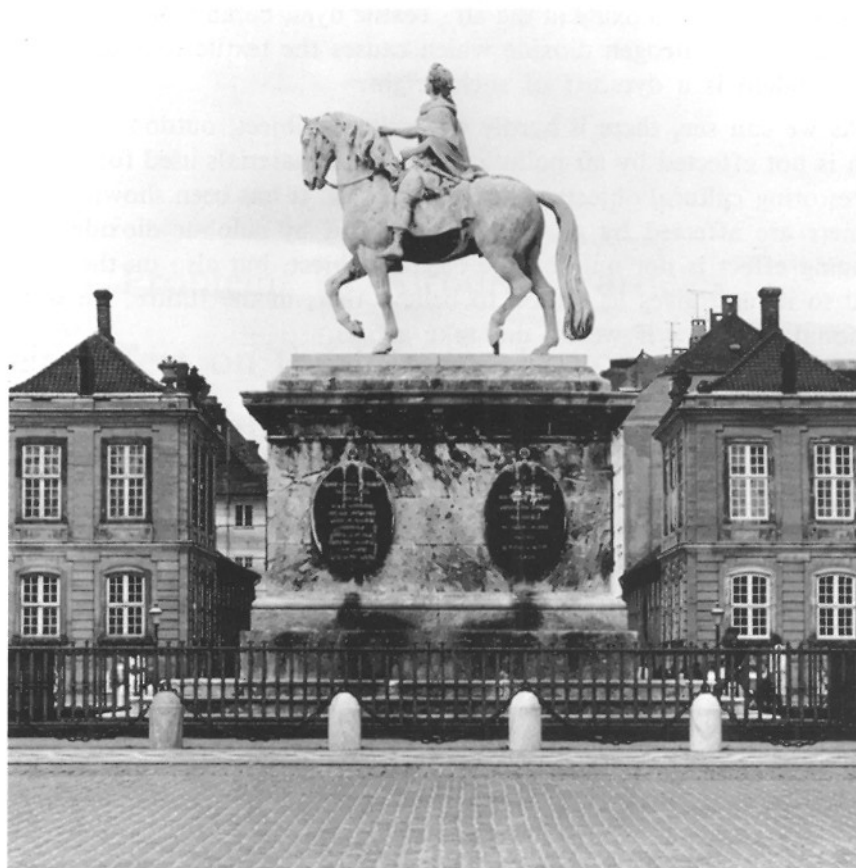
*Fig. 5. F.J. Saly's equestrian statue in bronze, from 1983.*
